**Flood Control Project Maintenance  
Levee Inspections**  
**LMA District Cover Sheet**  
**Spring 2017 Levee Inspection Results**

**Sacramento Maintenance Yard Maintenance Area 0009**

Waterway			Bank	Unit Miles
Unit No. 01 Sacramento River			Left	19.35
	Spring (March - May)	Summer (June - August)	(September - November) Fall	Winter (December - February)
Unit Maintenance Rating (Fall Only)				
Date of Inspection	4/25/2017 - 4/26/2017			
DWR Inspector	Zach Jojola			
Accompanied By	Dave Williams Sacramento Maintenance Yard

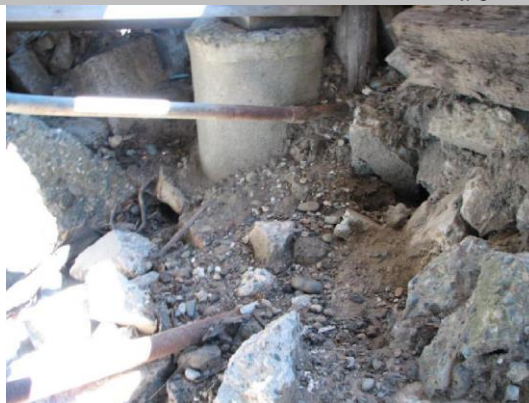
Photo 2 of 2 : UCIP\_SP\_2017\_5934\_9044.jpg

LM Start	17.50	Rating **	M	Issue No.	1843 (cont)	
LM End	17.50	Issue Type +	En	Location *	LS	
Category	Supplemental			GPS Latitude/Longitude		
				Start	End	
Item	DWR UCIP Field Study			38.368590 °	38.368590 °	
				-121.520310 °	-121.520310 °	
DWR ID						
Comment Code						
Inspector Comment						
FS_ID:5934 DS_ID:18965 EP_NO: N/A Repair Type: Non-Urgent Crossing Status: Found UCIP Comments: No permit identified for this crossing. FIELD_STRUCT_DESC: 2.5-inch steel electrical conduit 6-feet below the crown. Pipe visible under building on WS slope. FS Date: 6/26/2012 4:04:34 PM

Pipes through levee on WS slope.

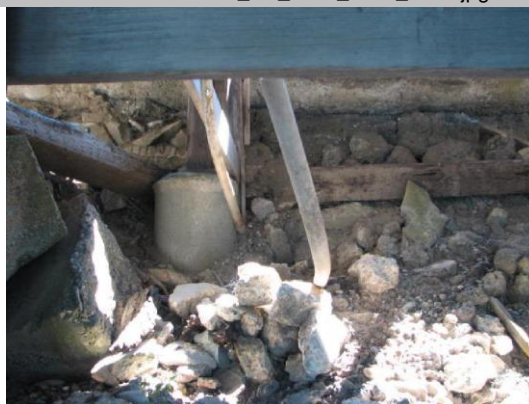
Photo 1 of 2 : UCIP\_SP\_2017\_5935\_9047.jpg

LM Start	17.50	Rating **	M	Issue No.	1844
LM End	17.50	Issue Type +	En	Location *	LS
Category	Supplemental			GPS Latitude/Longitude	
				Start	End
Item	DWR UCIP Field Study			38.368580 °	38.368580 °
				-121.520310 °	-121.520310 °
DWR ID					
Comment Code					
Inspector Comment					
FS_ID:5935 DS_ID:18966 EP_NO: N/A Repair Type: Non-Urgent Crossing Status: Found UCIP Comments: No permit identified for this crossing. FIELD_STRUCT_DESC: 2-inch steel electrical conduit 7-feet below the crown. Pipe visible under building on WS slope. FS Date: 6/26/2012 4:06:28 PM

Pipes through levee on WS slope.

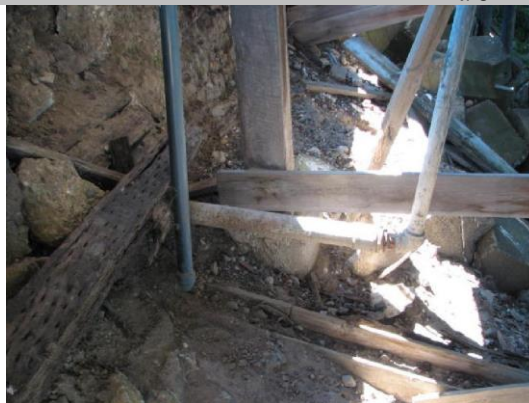
Photo 1 of 2 : UCIP\_SP\_2017\_5937\_9050.jpg

LM Start	17.50	Rating **	M	Issue No.	1846
LM End	17.50	Issue Type +	En	Location *	LS
Category	Supplemental			GPS Latitude/Longitude	
				Start	End
Item	DWR UCIP Field Study			38.368560 °	38.368560 °
				-121.520300 °	-121.520300 °
DWR ID					
Comment Code					
Inspector Comment					
FS_ID:5937 DS_ID:18967 EP_NO: N/A Repair Type: Non-Urgent Crossing Status: Found UCIP Comments: No permit identified for this crossing. FIELD_STRUCT_DESC: 4-inch steel waterline 5-feet below the crown. Pipe visible under building on WS slope. FS Date: 6/26/2012 4:08:42 PM

Pipes through levee on WS slope.

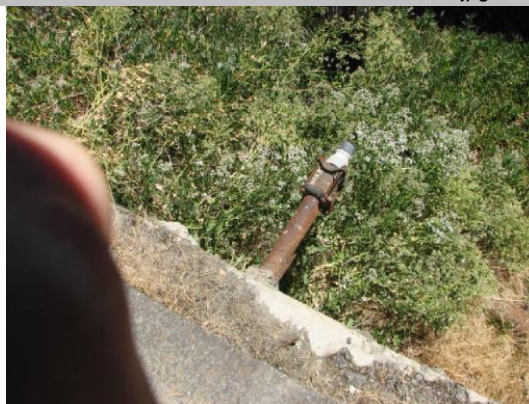
Photo 2 of 2 : UCIP\_SP\_2017\_5937\_9049.jpg

Pipe exiting from concret wall on LS shoulder.

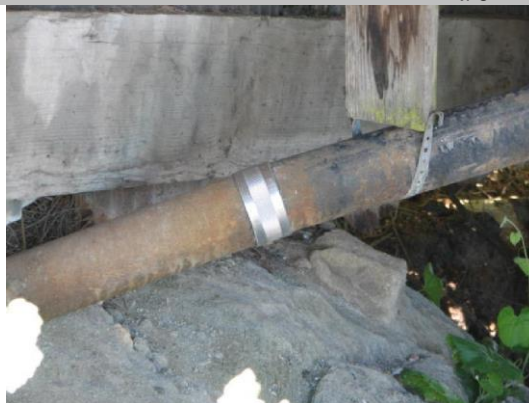
Photo 1 of 2 : UCIP\_SP\_2017\_5938\_9052.jpg

FS\_ID:5938  
DS\_ID:18969  
EP\_NO: N/A  
Repair Type: Non-Urgent  
Crossing Status: Found  
UCIP Comments: No permit identified for this crossing.  
FIELD\_STRUCT\_DESC: 4-inch cast iron sewer line 2.5-feet below the crown. Pipe visible on underside on building on WS slope.  
FS Date: 6/26/2012 4:10:08 PM

Pipe through levee on WS slope.

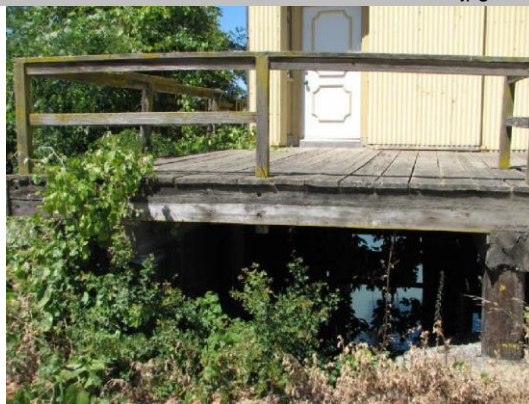
Photo 2 of 2 : UCIP\_SP\_2017\_5938\_9051.jpg

Pipe under south corner of building on WS slope.

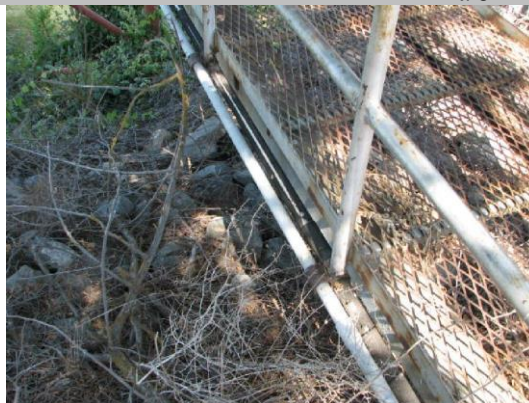
Photo 1 of 2 : UCIP\_SP\_2017\_5939\_9054.jpg

LM Start	17.57	Rating **	M	Issue No.	1848
LM End	17.57	Issue Type +	En	Location *	LS
Category	Supplemental			GPS Latitude/Longitude	
				Start	End
Item	DWR UCIP Field Study			38.367650 °	38.367650 °
				-121.520040 °	-121.520040 °
DWR ID					
Comment Code					
Inspector Comment					
FS_ID:5939					
DS_ID:18963					
EP_NO: N/A					
Repair Type: Non-Urgent					
Crossing Status: Found					
UCIP Comments: No permit identified for this crossing.					
FIELD_STRUCT_DESC: 1-inch PVC domestic waterline through the levee 1.5-feet below the crown. Pipe runs from corner of building to pumphouse catwalk on WS shoulder.					
FS Date: 7/25/2012 4:11:55 PM

PVC waterline on downstream side of pier walkway.

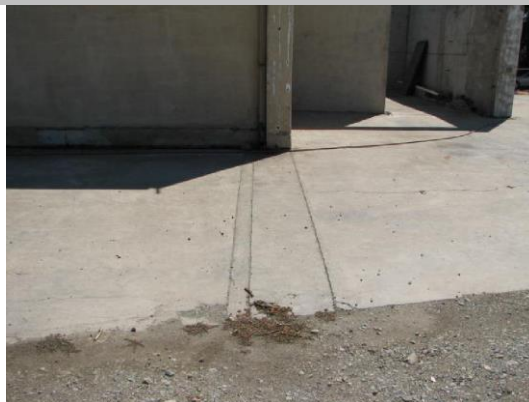
Photo 2 of 2 : UCIP\_SP\_2017\_5939\_9053.jpg

cut through concrete at building on LS shoulder where waterline was installed (per inspector).

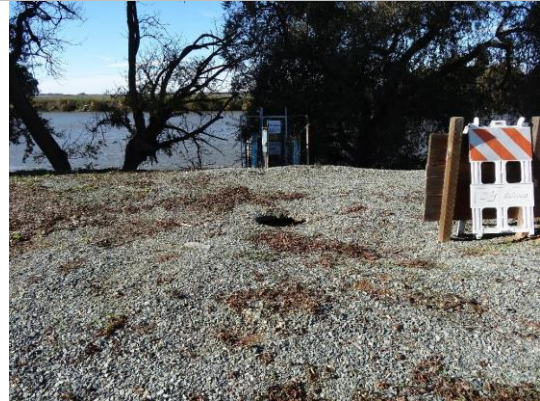
Photo 2 of 3 : UCIP\_SP\_2017\_51466\_76372.jpg

FS\_ID:51466  
DS\_ID:17682  
EP\_NO: 9635  
Repair Type: Urgent  
Crossing Status: Found  
UCIP Comments: 12/02/2016 Sink hole has developed in the last few weeks according to LMA representative. Hole through pipe section was also observed during inspection. Need to contact owner to inform owner of pipe failure and to stop use of crossing to avoid further damage to levee. (O. Magana - DWR UCIP)06/26/2012 No apparent closure device on pipe and pipe has no indication that it was properly abandoned. Urgent do to size of pipe. (W. Wylie - DWR UCIP)  
FIELD\_STRUCT\_DESC: 3 of 3: 36-inch corrugated metal drainage pipe through levee, 5 feet below the crown. Pipe runs under the pier walkway from the location of a removed fish screen test facility at centerline of levee back to river. A 4-inch steel conduit pipe runs parallel to 36-inch and terminates in 36-inch near WS slope. (Fish screen clogging engineering test facility with pump authorized under Permit No. 9635, 9635-B, 1974-CA DWR Central District Delta Branch; Permit No. 9635-A, 1977-CA DWR issued for 2 trailers on the crown and the installation of a septic system--facility is temporary should have been removed in July 1, 1977 per permit recordation page 29 or 76.)

WS view: Sink hole present along pipe alignment.

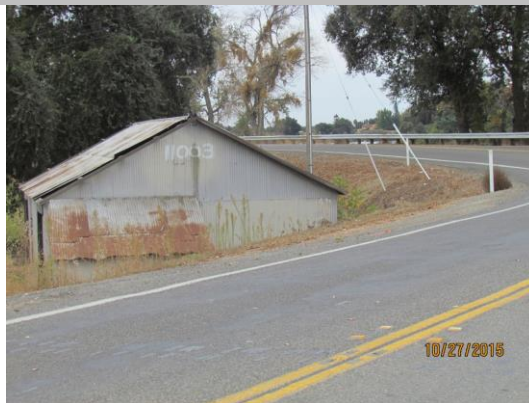
Photo 1 of 1 : SP\_2017\_MA0009\_201\_198\_20170320\_00161.jpg

LM Start	17.62	Rating **	M	Issue No.	198
LM End	17.62	Issue Type +	En	Location *	LS
Category	Earthen Levee			GPS Latitude/Longitude	
				Start	End
Item	Encroachments			38.366900 °	38.366900 °
				-121.520022 °	-121.520022 °
DWR ID	DWR_MA0009_01_s_2012_198				
Comment Code					
BU : Building					
Inspector Comment					
Pumphouse downstream of the Town of Hood.

View of the old pumphouse at the toe of the levee on the landward side looking downstream. Fall 2015.

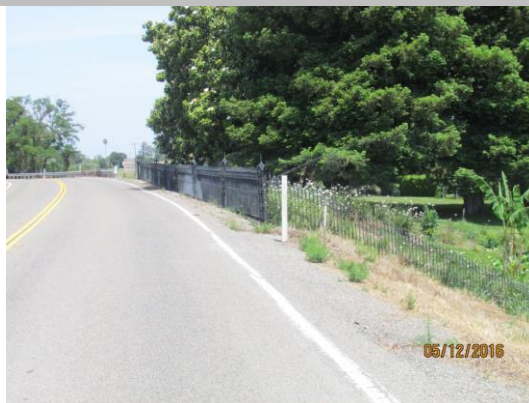
Photo 1 of 1 : SP\_2017\_MA0009\_201\_40\_20170320\_00034.jpg

LM Start	18.08	Rating **	M	Issue No.	40
LM End	18.08	Issue Type +	En	Location *	LS
Category	Earthen Levee			GPS Latitude/Longitude	
				Start	End
Item	Encroachments			38.360380 °	38.360380 °
				-121.520776 °	-121.520776 °
DWR ID	DWR_MA0009_01_s_2016_40				
Comment Code					
FE : Fence					
Inspector Comment

View of the wrought iron fence on the shoulder of the levee on the landward side looking upstream. Spring 2016.

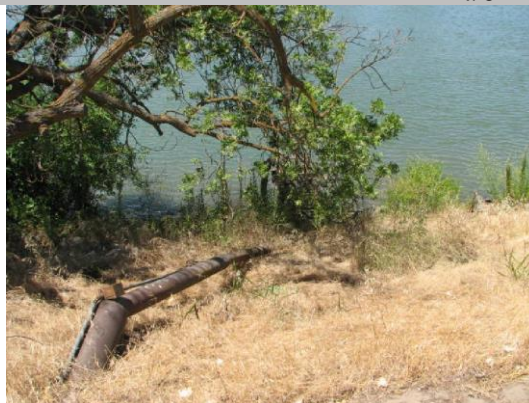
Photo 1 of 3 : UCIP\_SP\_2017\_41064\_7277.jpg

Comment Code					
Inspector Comment					
FS_ID:41064 DS_ID:17688 EP_NO: 2391 Repair Type: Non-Urgent Crossing Status: Found UCIP Comments: Pump and pipe appear to be abandoned. Need to properly abandon pipe and pump. Pier is a hazardous attractive nuisance. FIELD_STRUCT_DESC: 2 of 2: 12-inch pipe through levee, 7.3 feet below crown with an 8-inch pipe sleeved through it. Pipe and gate valve on waterward side attached to a pump on a pier. 1.25-inch galvanized steel electrical conduit through levee parallel to the 12-inch. 24-inch concrete standpipe, JP, and meter at LS toe (Permit No. 2391). Originally included in O+M manual (1955). FS Date: 6/26/2012 7:49:00 AM

12-inch with 8-inch on WS slope and 1.25-inch electrical conduit.

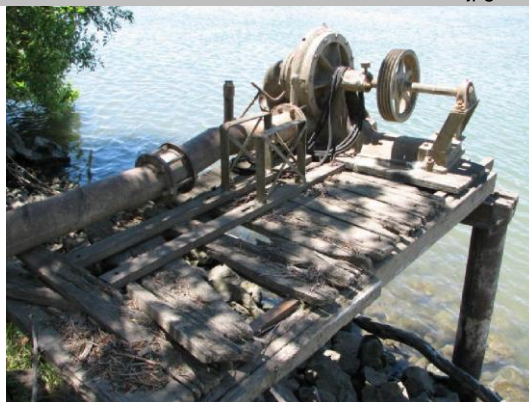
Photo 2 of 3 : UCIP\_SP\_2017\_41064\_7276.jpg

Pump on Pier on WS toe.

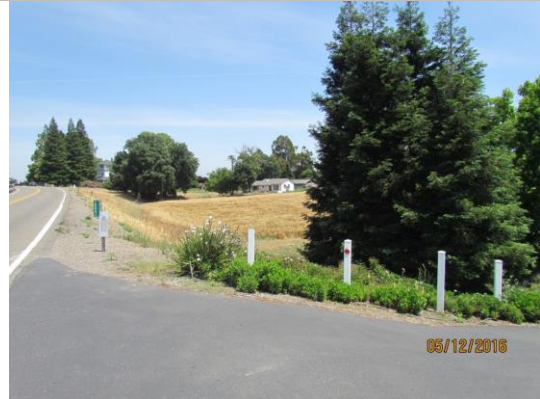
Photo 1 of 1 : SP\_2017\_MA0009\_201\_197\_20170320\_00160.jpg

LM Start	18.16	Rating **	M	Issue No.	197
LM End	18.16	Issue Type +	En	Location *	LS
Category	Earthen Levee			GPS Latitude/Longitude	
				Start	End
Item	Vegetation			38.359501 °	38.359501 °
				-121.521774 °	-121.521774 °
DWR ID	DWR_MA0009_01_s_2012_197				
Comment Code					
V6 : Landscaping					
Inspector Comment

View of the groundcover and redwood trees on the landward side of the levee looking upstream. Spring 2016.

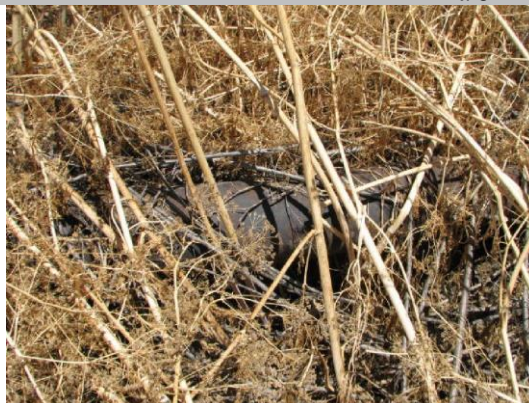
Photo 2 of 3 : UCIP\_SP\_2017\_5305\_7279.jpg

LM Start	18.22	Rating **	M	Issue No.	1851 (cont)
LM End	18.22	Issue Type +	En	Location *	LS
Category	Supplemental			GPS Latitude/Longitude	
				Start	End
Item	DWR UCIP Field Study			38.359050 °	38.359050 °
				-121.522800 °	-121.522800 °
DWR ID					
Comment Code					
Inspector Comment					
FS_ID:5305 DS_ID:17446 EP_NO: N/A Repair Type: Non-Urgent Crossing Status: Found UCIP Comments: Could not verify welded steel plates on either end of pipe. Pipe needs to be properly abandoned. FIELD_STRUCT_DESC: *ABANDONED* 10-inch pipe through levee, 8.8 feet below crown. Steel plate welded on both ends by United States Army Corps of Engineers. Pipe visible on LS 5-feet upstream from 4X4 concrete box on LS toe. Originally included in O+M manual (1955). FS Date: 6/26/2012 8:06:32 AM

Pipe on LS toe.

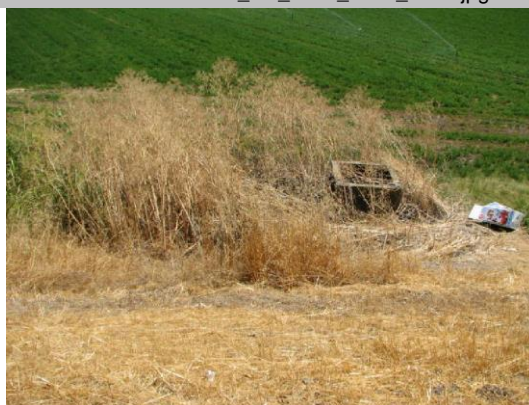
Photo 3 of 3 : UCIP\_SP\_2017\_5305\_7278.jpg

Pipe 5-feet upstream from 4X4 concrete box on LS toe.

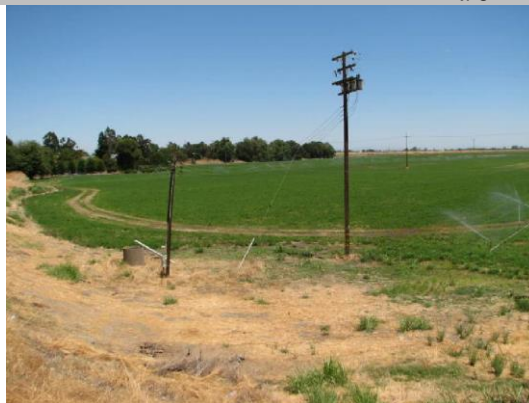
Photo 1 of 3 : UCIP\_SP\_2017\_5306\_7283.jpg

Comment Code					
Inspector Comment					
FS_ID:5306					
DS_ID:17447					
EP_NO: N/A					
Repair Type: Non-Urgent					
Crossing Status: Found					
UCIP Comments: Pump leaking oil and siphon breaker on landward slope is burried or has been removed. Need to repair oil leak, locate/repair siphon breaker, and remove foliage from around gate valve on WS.					
FIELD_STRUCT_DESC: 1 of 3: 10-inch pipe through levee, 7.0 feet below crown. Slant pump on pile structure in stream. Siphon break on landward slope burried. One cm cutoff wall. Service pole and concrete standpipe on landward side. Originally included in O+M manual (1955).					
FS Date: 6/26/2012 8:35:06 AM

Concrete standpipe, Joint pole, and meter on LS toe.

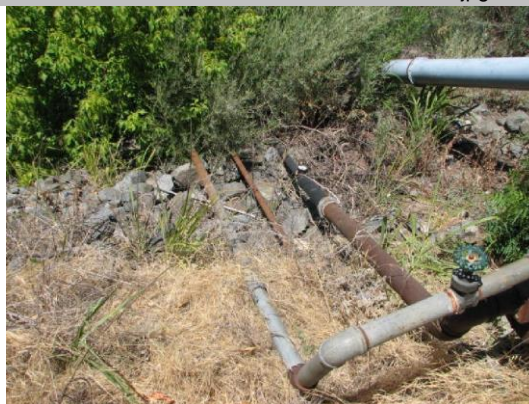
Photo 2 of 3 : UCIP\_SP\_2017\_5306\_7282.jpg

various pipes on WS slope that accompany the slant pump.

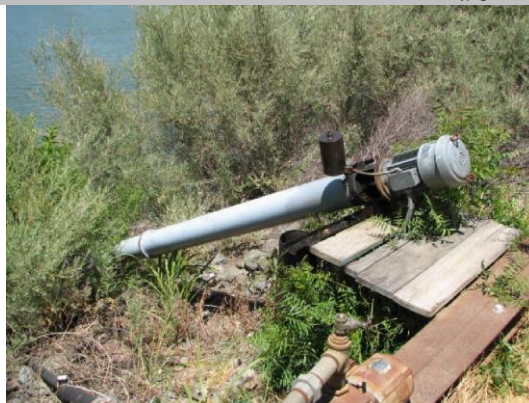
Photo 3 of 3 : UCIP\_SP\_2017\_5306\_7281.jpg

LM Start	18.31	Rating **	M	Issue No.	1852 (cont)	
LM End	18.31	Issue Type +	En	Location *	LS	
Category	Supplemental			GPS Latitude/Longitude		
				Start		End
Item	DWR UCIP Field Study			38.358430 °	38.358430 °	
				-121.524130 °	-121.524130 °	
DWR ID						
Comment Code						
Inspector Comment						
FS_ID:5306 DS_ID:17447 EP_NO: N/A Repair Type: Non-Urgent Crossing Status: Found UCIP Comments: Pump leaking oil and siphon breaker on landward slope is burried or has been removed. Need to repair oil leak, locate/repair siphon breaker, and remove foliage from around gate valve on WS. FIELD_STRUCT_DESC: 1 of 3: 10-inch pipe through levee, 7.0 feet below crown. Slant pump on pile structure in stream. Siphon break on landward slope burried. One cm cutoff wall. Service pole and concrete standpipe on landward side. Originally included in O+M manual (1955). FS Date: 6/26/2012 8:35:06 AM

Slant pump on pile structure on WS slope.

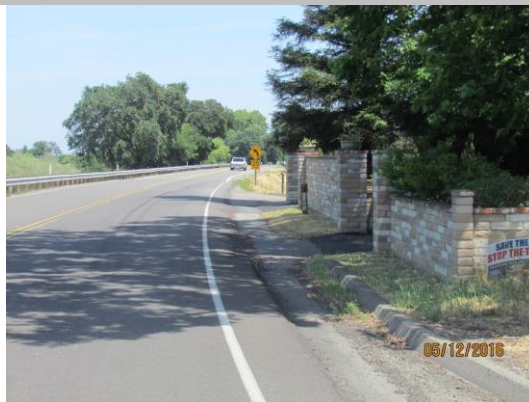
Photo 1 of 1 : SP\_2017\_MA0009\_201\_956\_20170320\_00299.jpg

LM Start	18.32	Rating **	M	Issue No.	956
LM End	18.32	Issue Type +	En	Location *	LS
Category	Earthen Levee			GPS Latitude/Longitude	
				Start	End
Item	Encroachments			38.358278 °	38.358278 °
				-121.524323 °	-121.524323 °
DWR ID	DWR_MA0009_01_s_2012_956				
Comment Code					
FE : Fence					
Inspector Comment

View of the brick wall and landscaping on the landward side of the levee looking upstream. Spring 2016.

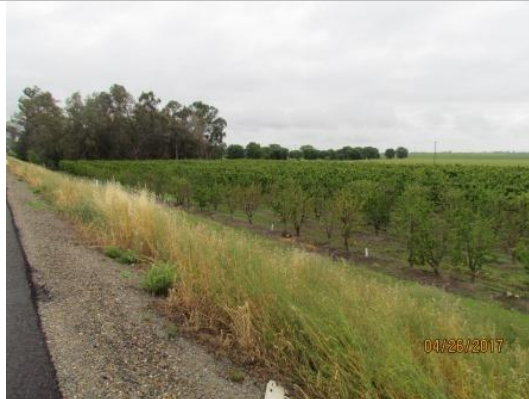
Photo 1 of 1 : SP\_2017\_MA0009\_201\_329\_20170426\_00512.jpg

LM Start	18.36	Rating **	U	Issue No.	329
LM End	18.95	Issue Type +	Ma	Location *	LS
Category	Earthen Levee			GPS Latitude/Longitude	
				Start	End
Item	Vegetation			38.358012 °	38.351319 °
				-121.524937 °	-121.531615 °
DWR ID	DWR_MA0009_01_s _ 2017_329				
Comment Code					
V1 : Control annual grass and weeds on the levee slopes and easements.					
Inspector Comment

View of tall vegetation on landside levee slope, blocking visibility. Spring 2017.

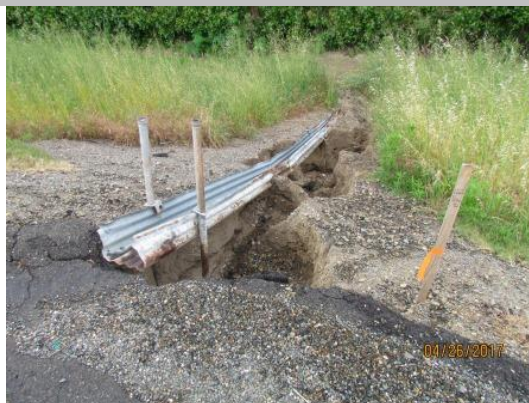
Photo 1 of 1 : SP\_2017\_MA0009\_201\_332\_20170426\_00513.jpg

LM Start	18.43	Rating **	U	Issue No.	332
LM End	18.43	Issue Type +	Ma	Location *	LS
Category	Earthen Levee			GPS Latitude/Longitude	
				Start	End
Item	Erosion / Bank Caving			38.357278 °	38.357278 °
				-121.525817 °	-121.525817 °
DWR ID	DWR_MA0009_01_s _ 2017_332				
Comment Code					
E2 : Schedule repair of erosion site prior to the next inspection.					
Inspector Comment					
Erosion on landside slope next to drainage gutter.

View of erosion on landside levee slope. Spring 2017.

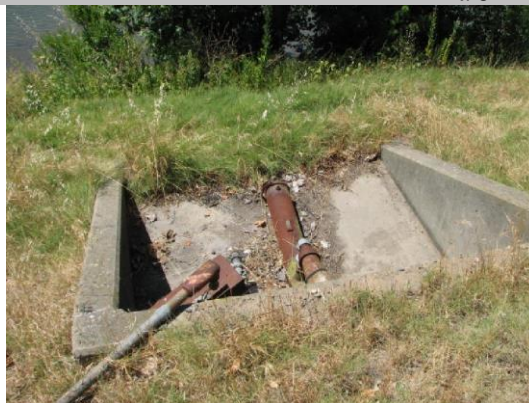
Photo 1 of 3 : UCIP\_SP\_2017\_5311\_7294.jpg

Comment Code					
Inspector Comment					
FS_ID:5311 DS_ID:17449 EP_NO: N/A Repair Type: Non-Urgent Crossing Status: Found UCIP Comments: No pump connection and no closure device found. Pipe needs to be closed and abandoned properly. Notes in levee log indicate that this pipe had welded steel plates but none were found on pipe ends. FIELD_STRUCT_DESC: 12-inch asphalt wrapped pipe with pipe sleeved through it 4.0 feet below crown. Pump components on concrete pad on waterward slope. Siphon breaker on landward slope is missing. Remnants of 36-inch concrete pipe riser on LS toe. One cm cutoff wall. 2-inch galvanized steel electrical conduit runs through levee to JP on LS. Originally included in O+M manual (1955). FS Date: 6/26/2012 9:33:51 AM

Concrete pad for missing pump on WS slope. 2-inch galvanized electrical conduit in foreground.

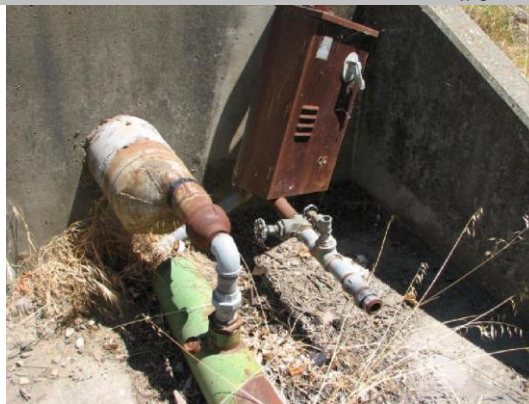
Photo 2 of 3 : UCIP\_SP\_2017\_5311\_7293.jpg

12-inch pipe with 4-inch attachment or sleeved through. Fuse box.

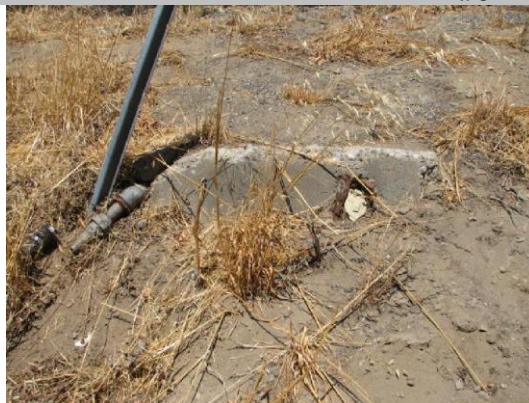
Photo 1 of 3 : UCIP\_SP\_2017\_5780\_8743.jpg

Comment Code					
Inspector Comment					
FS_ID:5780 DS_ID:17554 EP_NO: 6001 Repair Type: Non-Urgent Crossing Status: Found UCIP Comments: Black PVC pipe on LS shoulder not connected to 3-inch pipe through the levee and there is no shutoff valve. FIELD_STRUCT_DESC: 3-inch galvanized pipe through the levee 3-feet below the crown. Concrete boxes on both ends of pipe (steel sign post on LS shoulder marks concrete box.. Black PVC pipe runs up LS slope to concrete headwall and connection to 3-inch pipe. 3.5-inch white PVC runs down WS slope within a corrugated metal sluice. (Permit No. 6001). Electrical connection also noted on headwall. Minor design drawings available in permit. FS Date: 7/25/2012 2:58:03 PM

Concrete headwall on LS slope showing 3-inch pipe, electrical conduit, and sign post.

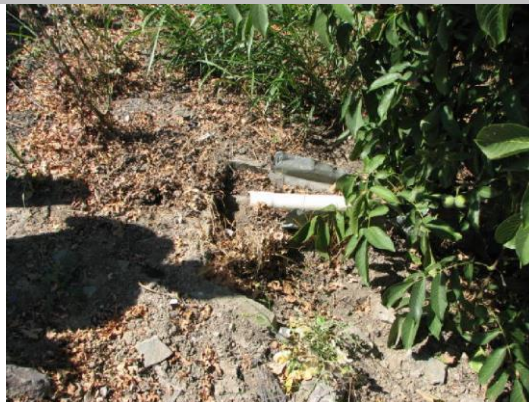
Photo 2 of 3 : UCIP\_SP\_2017\_5780\_8742.jpg

Concrete U shaped headwall at outlet showing white PVC pipe in corrugated metal sluice on WS shoulder.

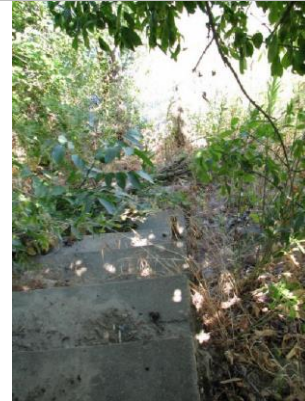
Photo 3 of 3 : UCIP\_SP\_2017\_5780\_8741.jpg

Concrete stairs on WS slope just upstream from pipe crossing.

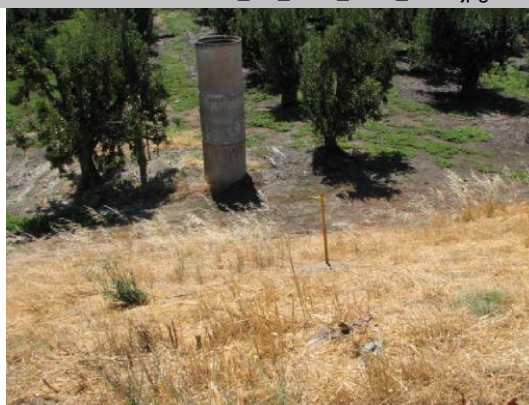
Photo 1 of 3 : UCIP\_SP\_2017\_5783\_8754.jpg

Comment Code					
Inspector Comment					
FS_ID:5783 DS_ID:17451 EP_NO: N/A Repair Type: Non-Urgent Crossing Status: Found UCIP Comments: Oil leaking all over pump platform and ground around pump. CMP riser on LS slope is damaged and should be marked to prevent further damage of siphon breaker and roadway equipment. FIELD_STRUCT_DESC: 12-inch pipe through levee, 4.5 feet below crown. Slant Pump on pile structure on WS slope. Siphon breaker on landward slope. 1.5-inch galvanized electrical conduit 4.5-feet below the crown from JP on LS toe to Breaker on slant pump pier. 36-inch Concrete standpipe on LS toe. One cm cutoff wall. Originally included in O+M manual (1955). FS Date: 7/25/2012 3:15:00 PM

36-inch concrete standpipe on LS toe.

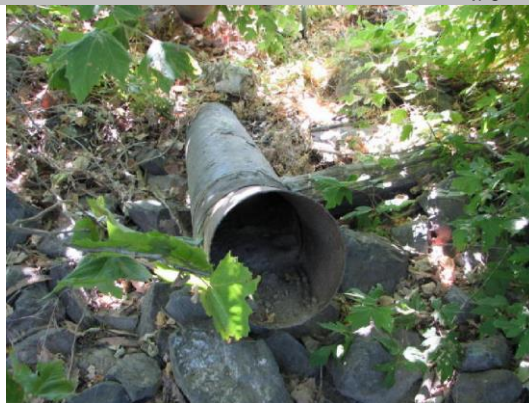
Photo 1 of 3 : UCIP\_SP\_2017\_51259\_20818.jpg

FS\_ID:51259  
DS\_ID:17579  
EP\_NO: N/A  
Repair Type: Urgent  
Crossing Status: Found  
UCIP Comments: 12/02/2016 same as last inspection. Owner will need to coordinate with CVFPB to comply with Title 23. Crossing remains "Urgent" due to pipe being opened on both WS and LS. (O. Magana - DWR UCIP)07/25/2012 This pipe has been abandoned improperly as it is open on the WS (it should be grouted in place or removed. Original slant pump piping and walkway are still visible on WS slope and may need to be removed. (W. Wylie - DWR UCIP)  
FIELD\_STRUCT\_DESC: \*ABANDONED\* 12-inch steel irrigation pipe through the levee, 6.5 feet below the crown. This pipe is located 2 feet below the 12-inch pipe currently in use (2012). Pipe originally included in USACE O&M manual (1959) as a 10-inch pipe. [Additional Reference(s): DWR Levee Log, 1991. USACE Sacramento O&M Manual Unit 111, May 1959 (Station 36.88)].

12-inch abandoned pipe open on WS.

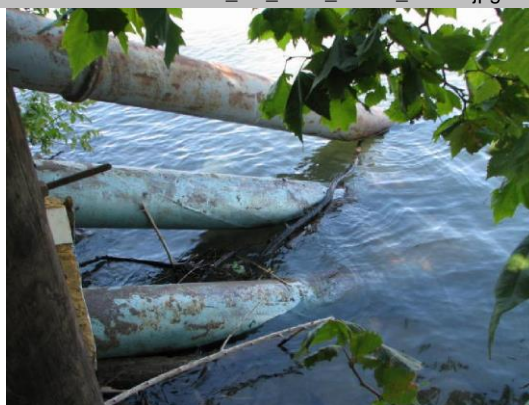
Photo 2 of 3 : UCIP\_SP\_2017\_51259\_20817.jpg

3-separate suction pipes on WS slope. All but one abandoned and left open.

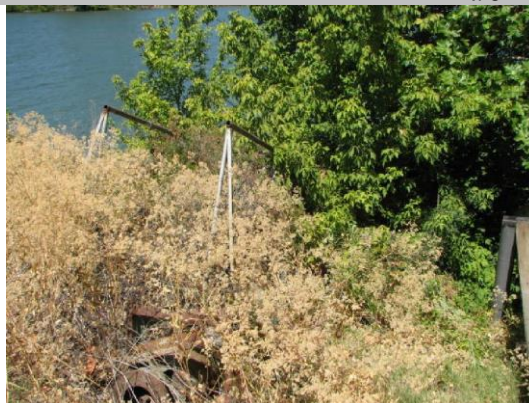
Photo 3 of 3 : UCIP\_SP\_2017\_51259\_20816.jpg

Discarded metal walkway ramp and slant pump appurtenances on WS slope.

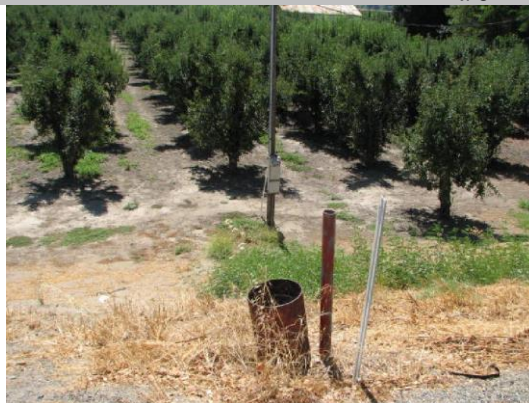
Photo 1 of 3 : UCIP\_SP\_2017\_5943\_9076.jpg

LM Start	19.13	Rating **	M	Issue No.	1857
LM End	19.13	Issue Type +	En	Location *	LS
Category	Supplemental			GPS Latitude/Longitude	
				Start	End
Item	DWR UCIP Field Study			38.349330 °	38.349330 °
				-121.533830 °	-121.533830 °
DWR ID					
Comment Code					
Inspector Comment					
FS_ID:5943 DS_ID:17477 EP_NO: N/A Repair Type: Non-Urgent Crossing Status: Found UCIP Comments: This pipe is a good candidate for video inspection. headwall is cracked and generally looking in poor repair. This may need some work. FIELD_STRUCT_DESC: 10-inch pipe through levee, 3.0 feet below crown. Pump on concrete pad waterward slope with a siphon breaker in a 12-inch steel riser on the LS shoulder and a shutoff valve on the WS shoulder. Service pole on landward slope. Originally included in O+M manual as a 3-inch pipe(1955). FS Date: 7/25/2012 3:45:00 PM

Siphon breaker on LS shoulder with JP and meter on LS toe.

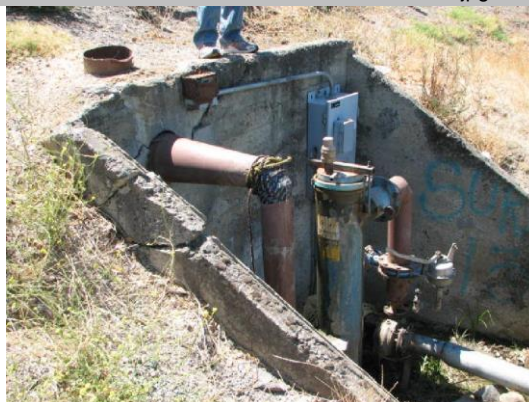
Photo 2 of 3 : UCIP\_SP\_2017\_5943\_9075.jpg

Pump on Concrete pad WS slope. meter and valve on headwall.
